An **AEIS** Case Study

**Case Study:  
Failure Analysis of a  
Weld Neck Flange  
in a Refinery**

*By Nagesh Goel  
Technical Director*

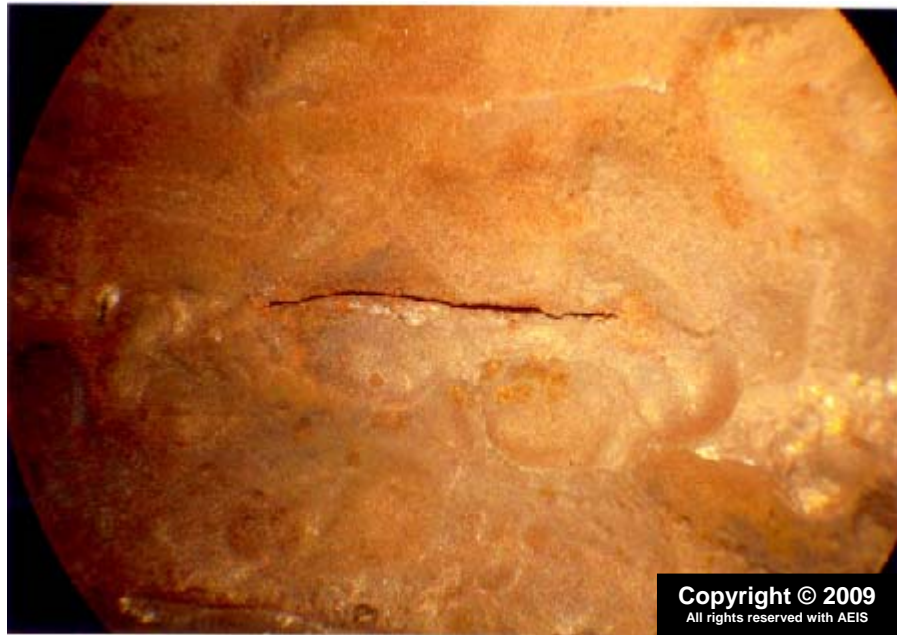
A rectangular section was cut around the above mentioned crack and examined under a low powered stereo microscope. The crack was located along the reducer side toe of the butt weld. The inside surface of the crack opening is shown in Figure 3. Two additional (smaller) crack like openings on the inside surface were observed within 1½ inch from the apparent end of the main crack. These indications had orange corrosion product spots at the lips and had similar orientation as the main crack. The longer of these cracks as observed on the inside surface is shown in Figure 4.

Figure 3: Crack Lips on the Inside Surface

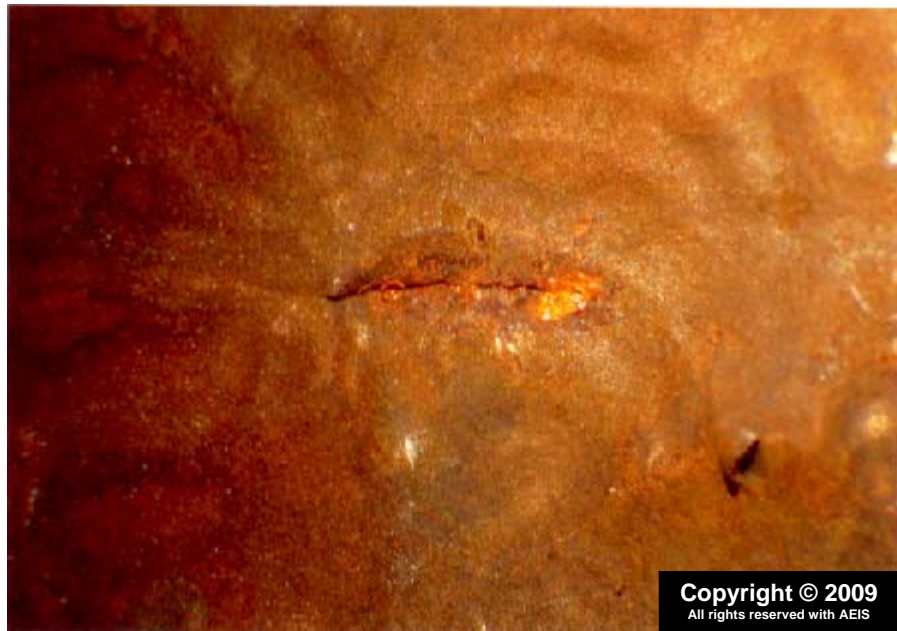
Figure 4: Another Crack Lip on the Inside Surface.

The acute dent at the outer surface was observed to be opposite to the second crack seen on the internal surface. This dent had abrasion marking on its side and metal flow at the lip suggesting that this was caused by a sharp tool such as chipping hammer used for slag removal. A similar dent was also observed opposite the third crack which was the smallest observed in the vicinity. The mechanical notches initiated these cracks.

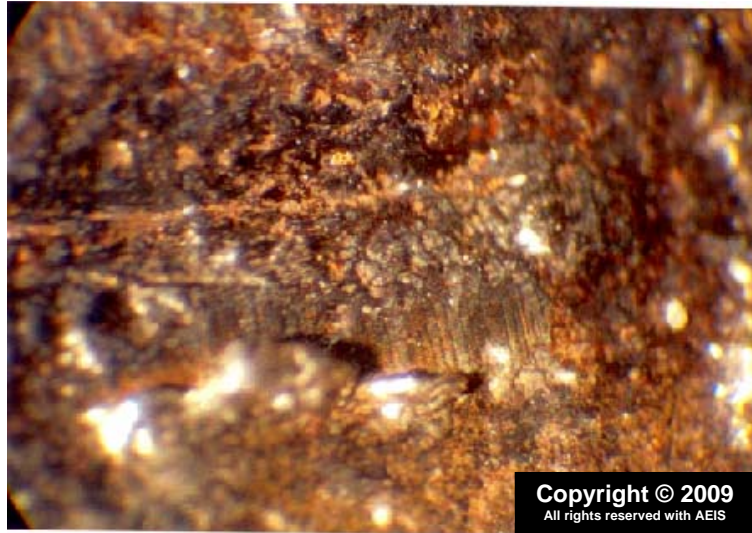
Some sharp mechanical dents on the outside surface were observed near the weld zone, Figure 5. The wedge shaped dents had abrasion lines on the side and displaced metal at the lip, Figure 6. It appeared that the crack like indications on the inside surface had corresponding dent marks on the inside.

Figure 6: Abrasion Marks and Displaced Metal

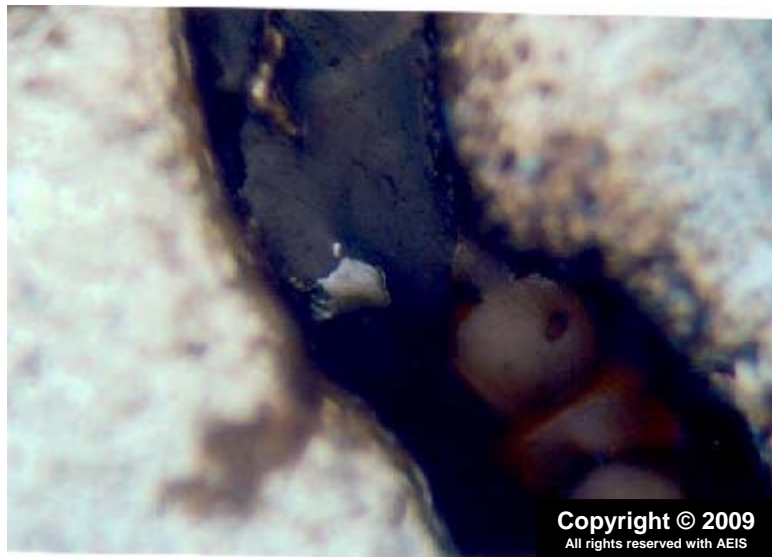
Figure 10: Slag on Internal Surface of the Crack near the Inside Surface

The stresses concentration is inherently high at the weld toes. Cracking will initiate at the edge in absence of any other weakness. The larger crack, in this case, had an additional deficiency. Microscopic examination showed the presence of slag inside the crack, implying that there was a lack of fusion and or undercut in the weld. Gradual gouging of metal from inside continued till the wall thickness at the weakness gave way. Another weld weakness can be observed in Figure 14.

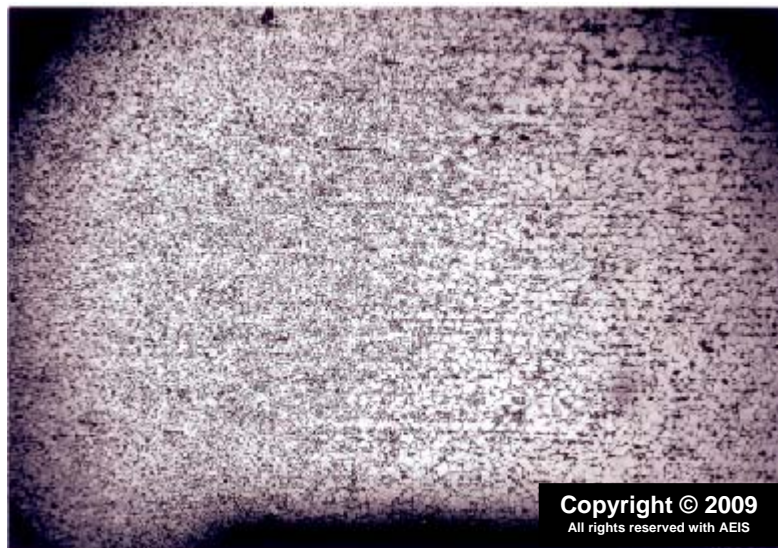
Figure 12: Microstructure of the Heat Affected Zone of the Reducer 100X Magnification.

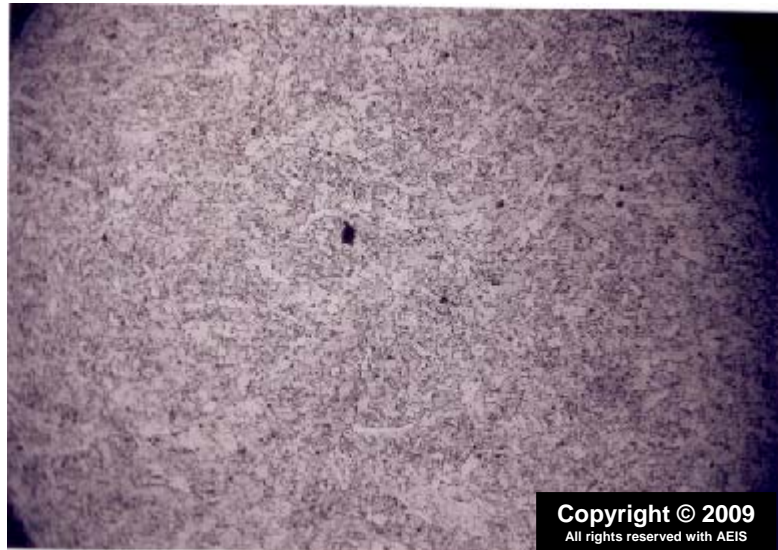
Figure 13: Microstructure of the Weld Metal Pool 100X Magnification

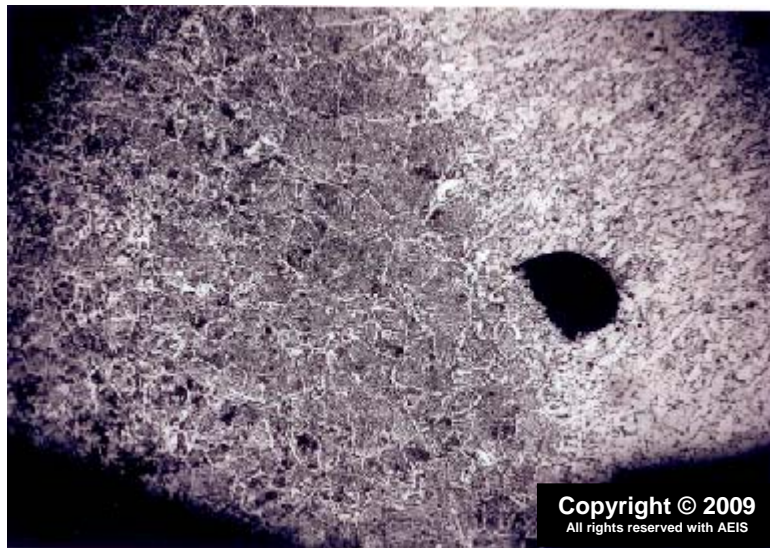
A section was cut through the confirmed crack and the cross section was prepared for microscopic examination. The unetched specimen showed that the flange side of the crack had elongated inclusions typical of forging. The weld side of the crack showed wide spherical non-metallic inclusions typical of a weld metal pool, Figure 7. The etched microstructure revealed the two sides of the crack as shown in Figure 8. Some slag was observed on the internal surface of the crack, near the outside opening of the crack, Figure 9, as well as near the inside opening of the crack, Figure 10. The variance in microstructure at 100X magnification is shown Figures 11 through 16. Figure 11 shows the microstructure of the reducer parent metal. Figure 12 shows the microstructure of the heat affected zone (HAZ) of the reducer. The microstructure of the weld metal pool is shown in Figure 13. Figure 14 shows the weld metal pool to the weld neck flange (WNF) interface. Figure 15 shows the heat affected zone of the WNF and the Figure 16 shows the microstructure of the WNF flange parent material. Internal cracks were observed. Inclusions such as mentioned earlier in and as seen in Figure 14 were observed.

Figure 14: Weld Metal Pool to Weld Neck Flange Interface  
100X Magnification

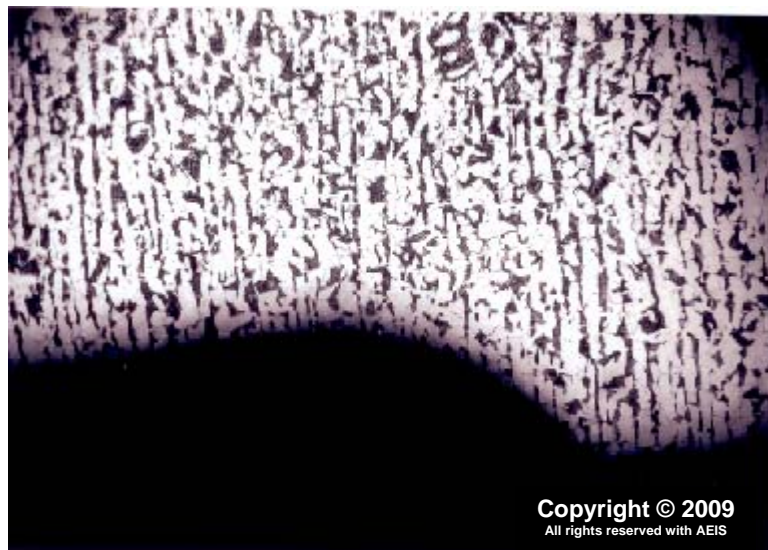
Figure 16: Microstructure of the Weld Neck Flange Parent Material  
100X Magnification
